Springbrook Creek Wetland and Habitat Mitigation Bank Units A and B

USACE IP 200600100

2015 MONITORING REPORT

**Washington State
Department of Transportation**

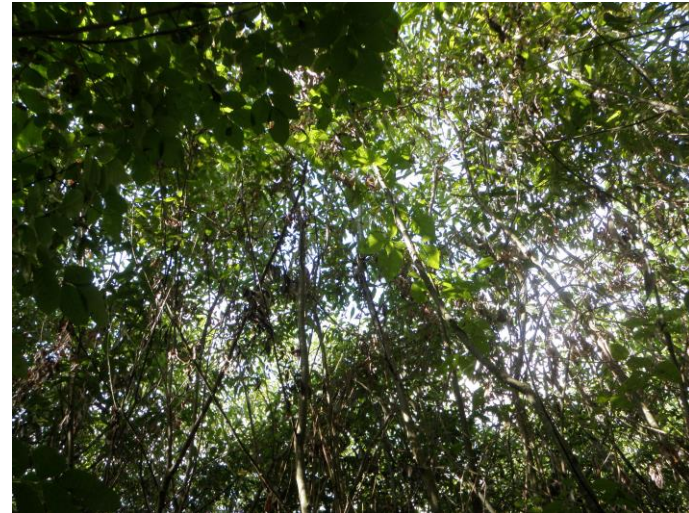
Photo 1
Native woody cover in the wetland tree/shrub planting area (August 2015)

Cover of native woody vegetation in the wetland tree/shrub planting areas is estimated at 99 percent ($CI_{95\%} = 99-100\%$). This value exceeds the performance standard target. Dominant species are willows. (Photo 1)
